# Manhole Inspection Summary

Manhole # S19AA\_052MH

**Location** Address: **2110 N SMALLWOOD ST** Cross Street: **W LAFAYETTE AVE**

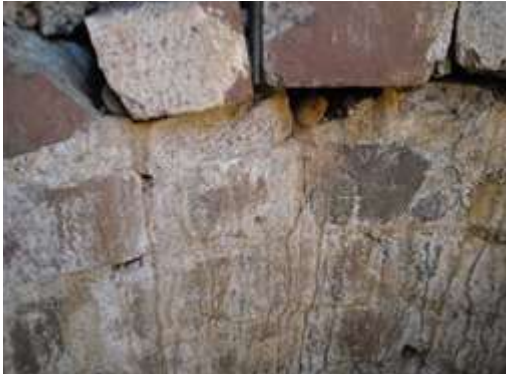
Defect 3

**Frame** Offset: **0** (in.) Condition: ☐ Sound ☐ Cracked ☒ **Leaks**

**Chimney / Frame Adjustment** ☐ Exists Material: **Brick** ☐ Parged Height: **4** (in.)  
Condition: ☐ Sound ☐ Cracked ☐ Root Intrusion ☐ Loose Brick ☒ **Deteriorated**  
Infiltration: ☐ None ☒ **Joint** ☐ Cracks ☐ Mortar ☐ Roots ☐ Wall

EVIDENCE OF INFILTRATION -  
BELIEVE FRAME/CHIMNEY JOINT  
LEAKS

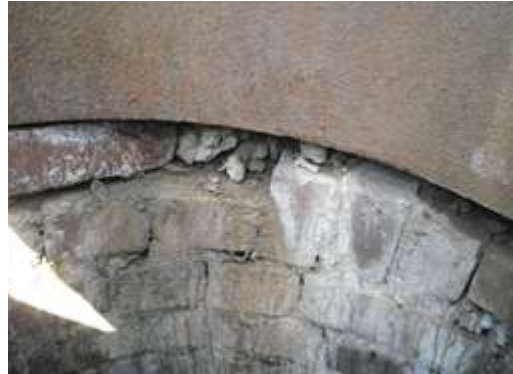
Defect 2

MISSING BRICK IN CHIMNEY

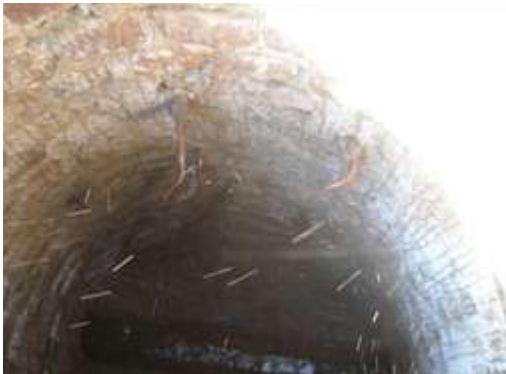
Defect 1

**Steps** Count: **2** Missing: **2** ☒ **Corroded**

MISSING STEPS

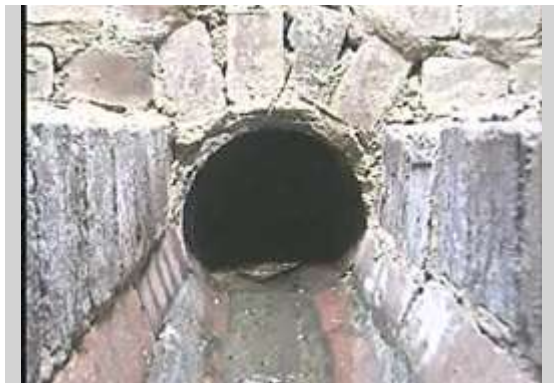
12 O'Clock Outflow

10 in. Circular Gravity Sewer  
Pipe Out @ 12 O'Clock

Pipe Height: **9.6** (in.) Rod and Bar (Angled)  
Pipe Material: **Clay** ☐ Pipe Lined  
Invert Depth: **7.65** (ft.) Flow Characteristics: **Slow**  
Deposits: ☒ None ☐ Mud ☐ Sludge ☐ Debris ☐ Grease  
Silt Depth: (in.) Deposits Extent:  
Infiltration: **None** Pipe Seal Cond: **Sound**

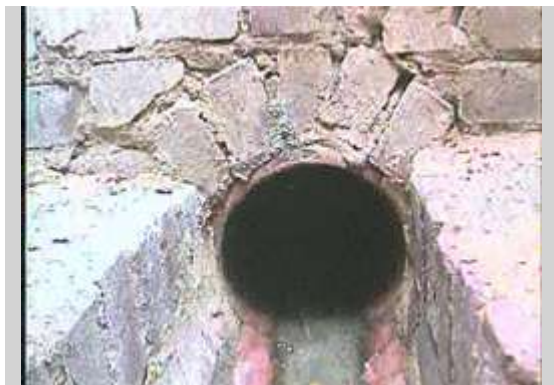
6 O'Clock Inflow

10 in. Circular Gravity Sewer  
Pipe In @ 6 O'Clock

Pipe Height: **10.8** (in.) Rod and Bar (Angled)  
Pipe Material: **Clay** ☐ Pipe Lined  
Invert Depth: **7.47** (ft.) Flow Characteristics: **Slow**  
Deposits: ☒ None ☐ Mud ☐ Sludge ☐ Debris ☐ Grease  
Silt Depth: (in.) Deposits Extent:  
Infiltration: **None** Pipe Seal Cond: **Sound**
